# Manhole Inspection Summary

Manhole # S47KK\_015MH

Insp Date: **3/15/10 1:19 PM**

**Location** Address: **Gay st**

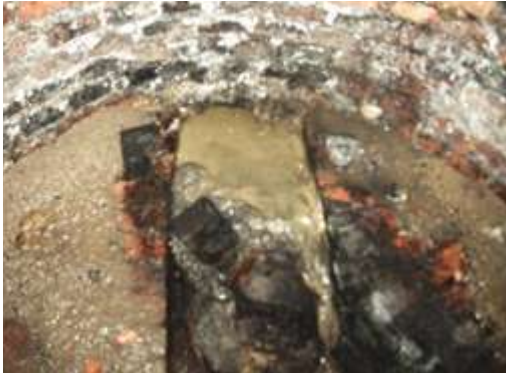
Defect 4

debris

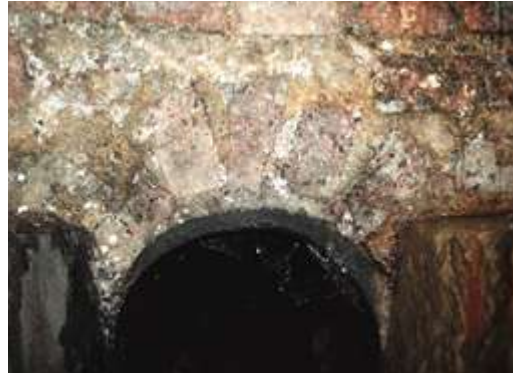
Defect 3

infiltration

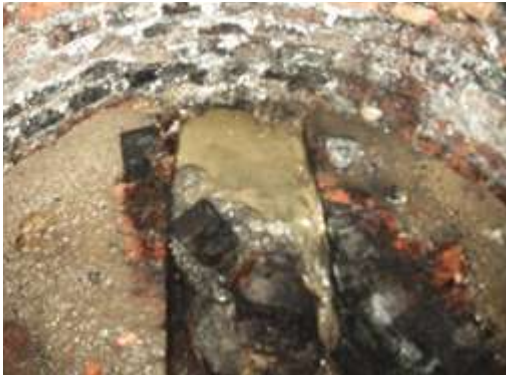
Defect 2

debris

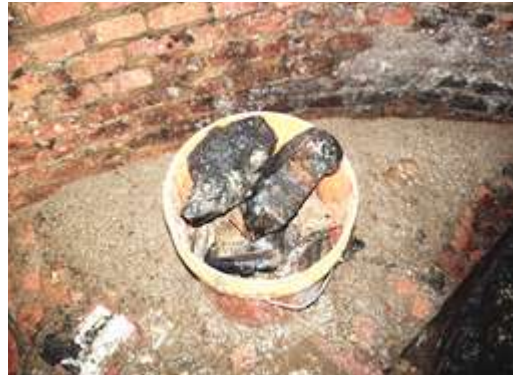
Defect 1

debris

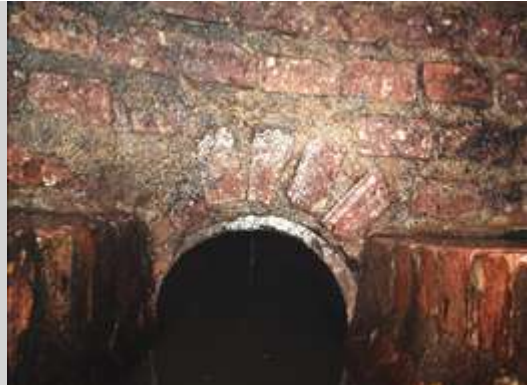
12 O'Clock Outflow

10 in. Circular Gravity Sewer  
Pipe Out @ 12 O'Clock

Pipe Height: **14.4** (in.) Rod and Bar (Angled)  
Pipe Material: **Clay** ☐ Pipe Lined  
Invert Depth: **25.00** (ft.) Flow Characteristics: **Slow**  
Deposits: ☒ None ☐ Mud ☐ Sludge ☐ **Debris** ☐ Grease  
Silt Depth: (in.) Deposits Extent:  
Infiltration: **None** Pipe Seal Cond: **Sound**

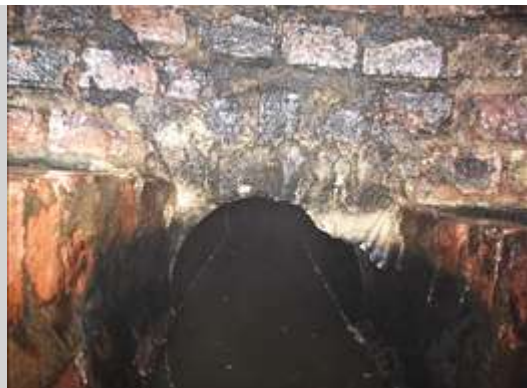
7 O'Clock Inflow

10 in. Circular Gravity Sewer  
Pipe In @ 7 O'Clock

Pipe Height: **14.4** (in.) Rod and Bar (Angled)  
Pipe Material: **Clay** ☐ Pipe Lined  
Invert Depth: **24.83** (ft.) Flow Characteristics: **Slow**  
Deposits: ☐ None ☐ Mud ☐ Sludge ☒ **Debris** ☐ Grease  
Silt Depth: **9** (in.) Deposits Extent: **Heavy**  
Infiltration: **None** Pipe Seal Cond: **Sound**
